## Pig'N Whistle MFR Report - Cultural Heritage Commission Agenda

Re: **Agenda Item 4 – General Public Comment**

I call on you to take on as an agenda item the matter of restoring the unpermitted damage done to the Pig & Whistle (aka Pig'N Whistle) restaurant located at 6714 Hollywood Blvd. The public deserves a clear and accurate accounting of the damage done and the actions to be taken to rectify this matter.

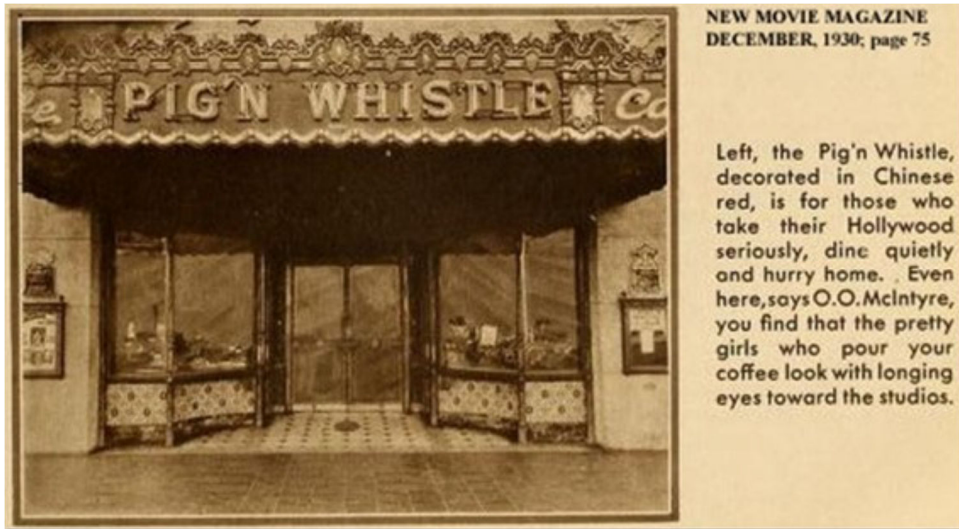
The original Pig'N Whistle storefront is a classic design from the period. The entry doors are set in the center of the storefront and recessed back from the sidewalk. The two enclosed areas form a

short hallway with patrons passing by product displays or diners, if used for seating. The effect is to be inviting, to draw people in, to get people away from the busy street and into the shop.

**Figure 1** - MFR Report Figure 6 “shows the 1927 storefront, which consisted of a pair of small outdoor spaces that functioned as patios and the original signage on the marquee.”

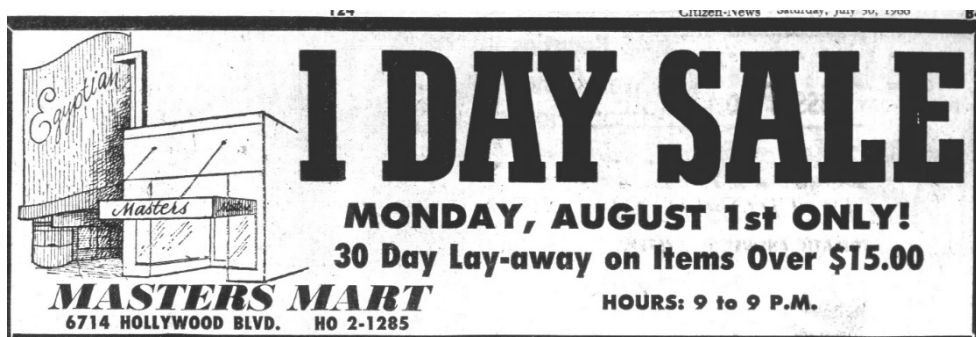
The next graphic (Figure 2) shows Masters Mart retaining the classic storefront configuration. The major changes involve the enclosure of the patio areas with sheet glass, thus providing areas for product display, and a change in signage. It is likely safe to assume that the Pig’N Whistle tile on the two exterior walls did not survive the change. It is not known how much, if any, of the entrance way tile shown in Figure 1 survived the change.

**Figure 2** – Sale ad for Masters Mart on Hollywood Blvd. Source: Los Angeles Times dated 22 April 1966.

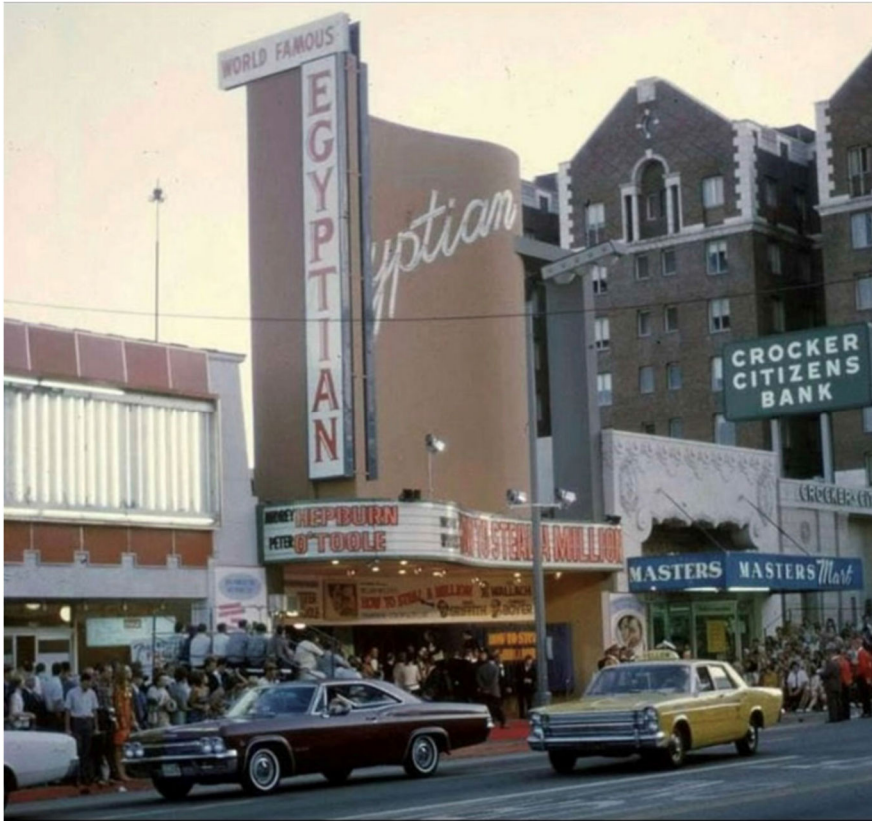
**Figure 3** - MFR Report Figure 8 “shows the Pig’N Whistle circa 1960 when it was converted to a Masters Market. SOURCE: Photo provided by Sunset Entertainment Group.”

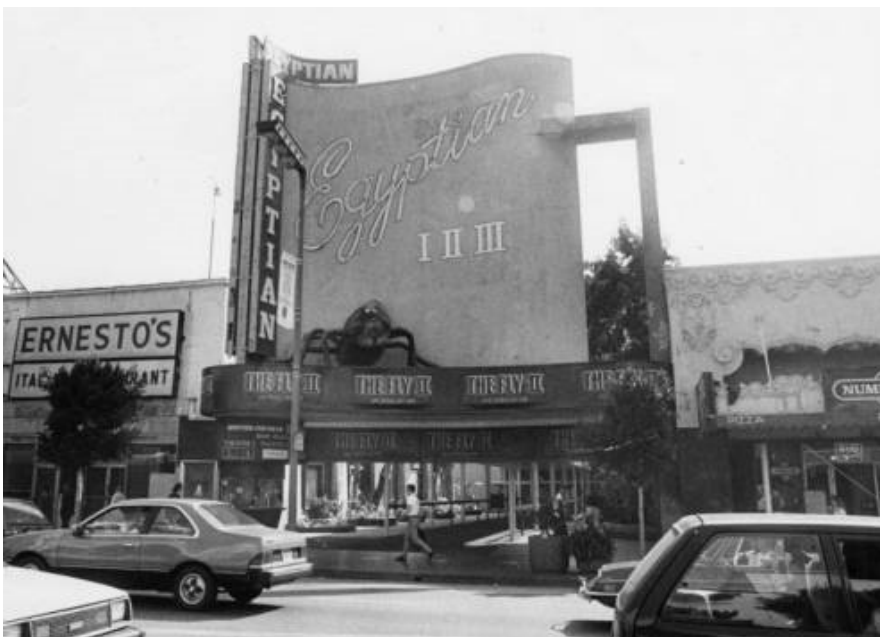
**Figure 4** – View of the Egyptian Theater and a partial view of the Numero Uno Pizza storefront dated 24 February 1989. Source: LAPL Photo Collection.

Moving ahead to the next major tenant, Numero Uno Pizza operated at this address from 1983 to slightly before 2000. A photo of the Egyptian Theater taken in 1989 shows the eastern edge of the building. While it is hard to make out, it appears that Numero Uno retained the enclosed glass frontage with recessed doors. The glass windows will be removed, and the area returned to open-air patio in the 1999 – 2000 renovations. Where are the permits and site plans for this demolition work?

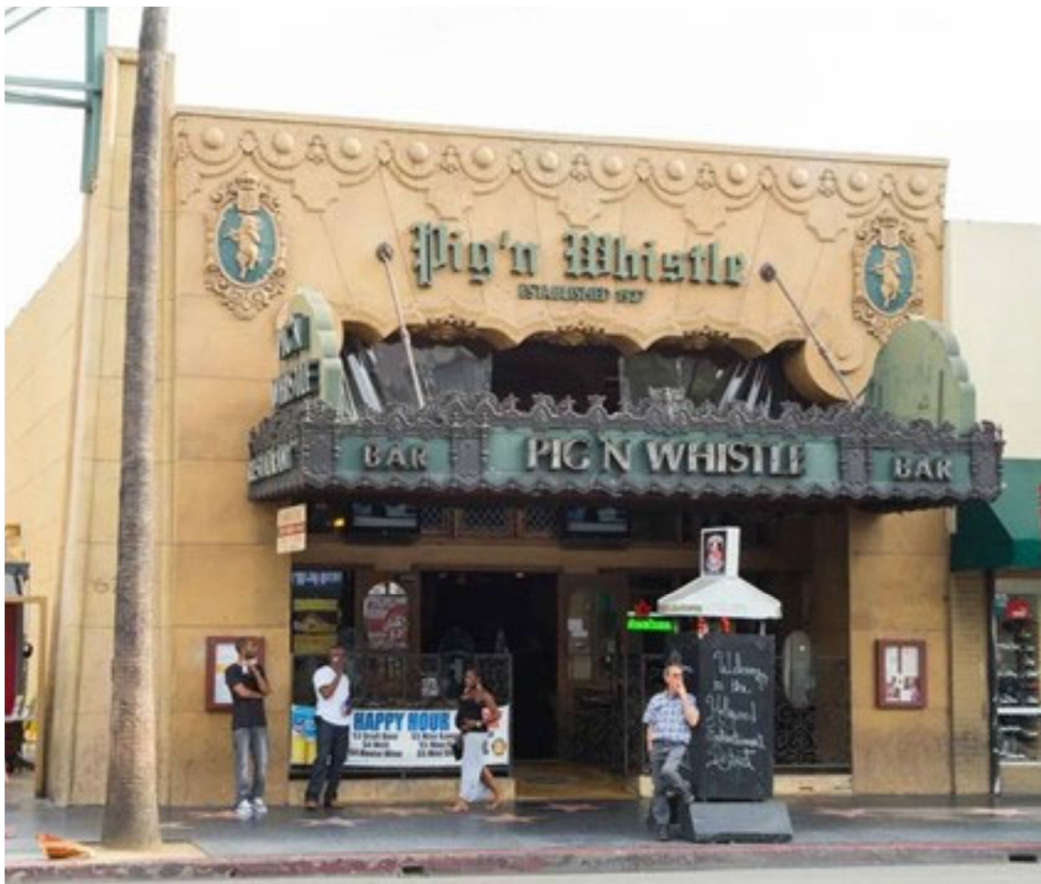
Figure 6 - MFR Report Figure 9 dated 2014. *“The marquee was restored as part of the 1999–2001 renovation, including reconstruction of the side fins with neon-lit channel signage. The extant channeled neon signage was added at that time. SOURCE: Photo provided by Sunset Entertainment Group.*

The MFR report claims that the storefront was “*pushed to the sidewalk to create a flat plane on the primary façade for security reasons in 2004.*” This is clearly false as shown in Figure 6 (MFR Report Figure 9 dated 2014). The photo clearly shows the two patio areas enclosed by the wrought iron railing with the partition wall in back. It is unknown exactly when this major change took place, but it did not occur in 2004.

I also call attention to the doors themselves. Figures 6, 7, and 8 clearly show two large doors with large glass inserts. The doors shown in Figure 10 (MFR report Figure 15) are narrow and mostly wood with small glass inserts at the top. If one can clearly see that these are different doors, why does the report claim that these are the original doors? One can see in Figures 6 and 10 (both from the MFR Report) that the doors have been changed.

- 6) Meetings shall be held with the owner and appropriate preservationists as to how best to restore the store front to 1999 condition while meeting the security needs of the building tenant. This discussion shall address both exterior and interior walls; and

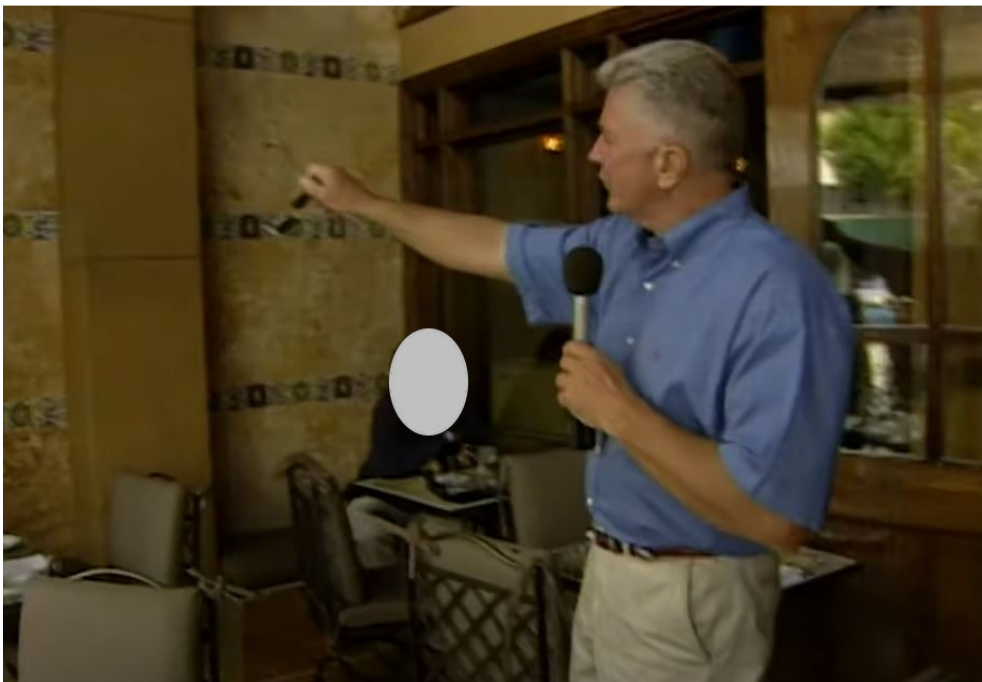
Figure 8 – Frame grab from Visiting with Huell (Season 9 Episode 9) aired 4 March 2001.

In the KCET program “Visiting with Huell” aired 4 March 2001, Huell Howser met with Robert Nudelman (Hollywood Heritage), Ken Burnstein (Los Angeles Conservancy), and owner Chris Breed to discuss the recent renovations made to the Pig’n Whistle. In this episode it is pointed out how historic tile from the basement was removed and reused to construct the center tile piece at the entrance, or it was used in the patio walls, and how broken pieces were used to construct tile tabletops for the patio area. Huell marveled as to how this historic tile was reused and will live on for all to enjoy. In reviewing the MFR report, there is no accounting for this historic tile. While the report clearly mentions the importance of the basement tile, the removed and reused tile is not addressed. Also notice the size and shape of the original wood doors in Figures 7 and 8. This issue will be brought up shortly.

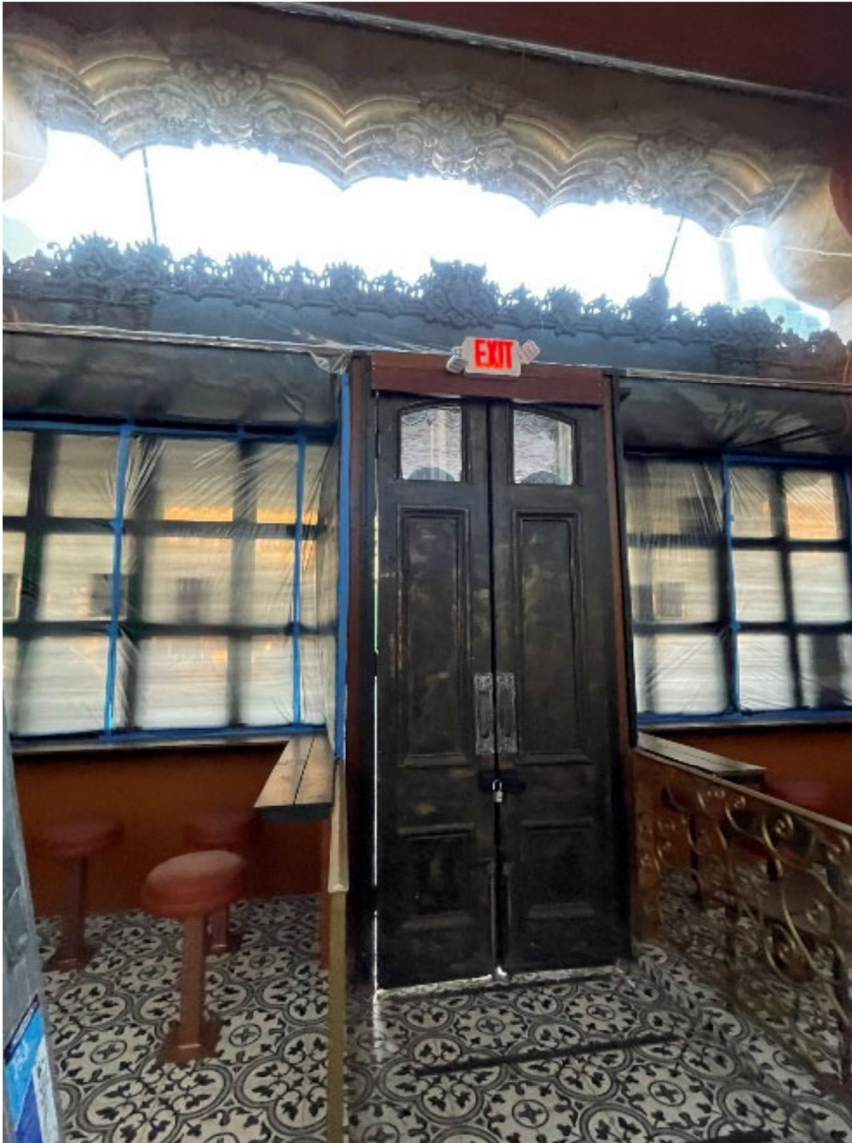
Figure 10 - MFR Report Figure 15 *“(Original Doors and Storefront Windows Extant). The patios were enclosed with contemporary storefront, and the original paired wood doors were pushed to the sidewalk to create a flat plane on the primary façade for security reasons in 2004. The interior arches were installed where the original primary façade plane was previously located. SOURCE: Sapphos Environmental, Inc., 2022. NOTE: Metal windows were added in 2001 for security.”*

The MRF report continues “*In 2004, the storefront windows were installed to enclose the front patios, and the entry doors were pushed out to create a flat plane on the primary façade. This alteration was completed for security purposes. Permits for the 2004 work were not available from the Department of Building and Safety and were not provided by the property owner.*” Might the absence of permits be due to the fact that the work was not conducted in 2004 or that the work was performed without permits? Where are the building plans for this work?

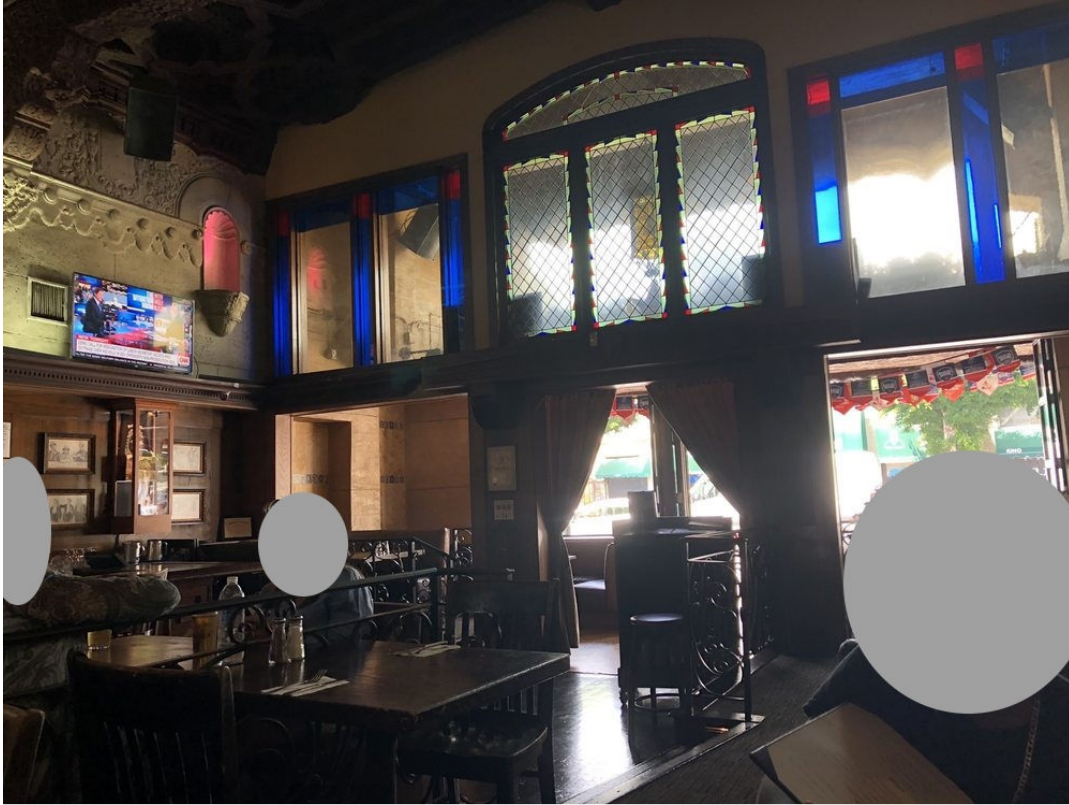
Continuing, I also believe that the interior wall itself is a significant feature worthy of preservation. This wall gets little mention in the MFR report. In an LA Times article dated 26 April 2001, it is claimed that “*English-born (Chris) Breed has restored the Pig’s old ceiling beams, the plaster light sconces, the stained-glass windows and the original marquee showing a pig playing a fife.*” The MFR report fails to mention any stained-glass windows as a historic feature. It is known that the interior wall did contain a number of stained-glass windows, and what appear to be cut glass panes, as shown in the following photo.

Figure 11 - Photo dated 9 July 2019 and posted on Yelp by Andrew B. This view is from inside the restaurant, looking out towards Hollywood Blvd.

Comparing Figure 11 to Figure 12, it appears that the current project has replaced all of the stained-glass and cut glass in the interior wall. It is also unknown if any of this interior wall still exists since it is not shown in the Site Plan (Figure 9). Also note in Figures 11 (July 2019) and 12 (January 2022) that the existing metal storefront windows are open. This is counter to the site plan that shows the existing metal storefront windows as “*fixed and non-openable.*” This is just another discrepancy not identified, discussed, or even mentioned in the MFR report.
